COUNTY OF VERMILION RIVER NO. 24 PROVINCE OF ALBERTA BY-LAW NO. 05-26

LakeView Estates Table of Contents

Development Concept and Servicing Plan

PHASE I ENVIRONMENTAL SITE ASSESSMENT VACANT UNDEVELOPED PROPERTY PORTION OF SW ¼, SEC. 19, TWP. 49, RGE. 1, W4M COUNTY OF VERMILION RIVER, ALBERTA

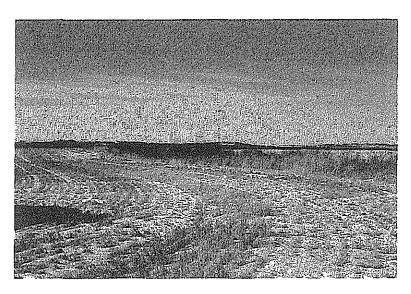
PHOTOGRAPH VIEWS WEST FROM THE NORTHEAST CORNER OF THE SITE ALONG DEVONIA LAKE

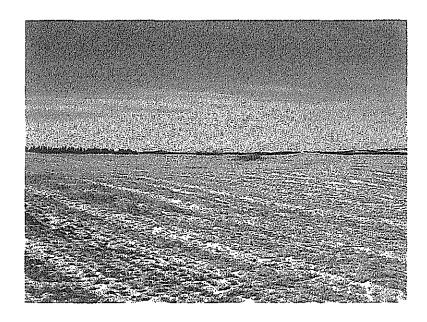
PHOTOGRAPH VIEWS NORTHEAST FROM THE SOUTHEAST CORNER OF THE SITE

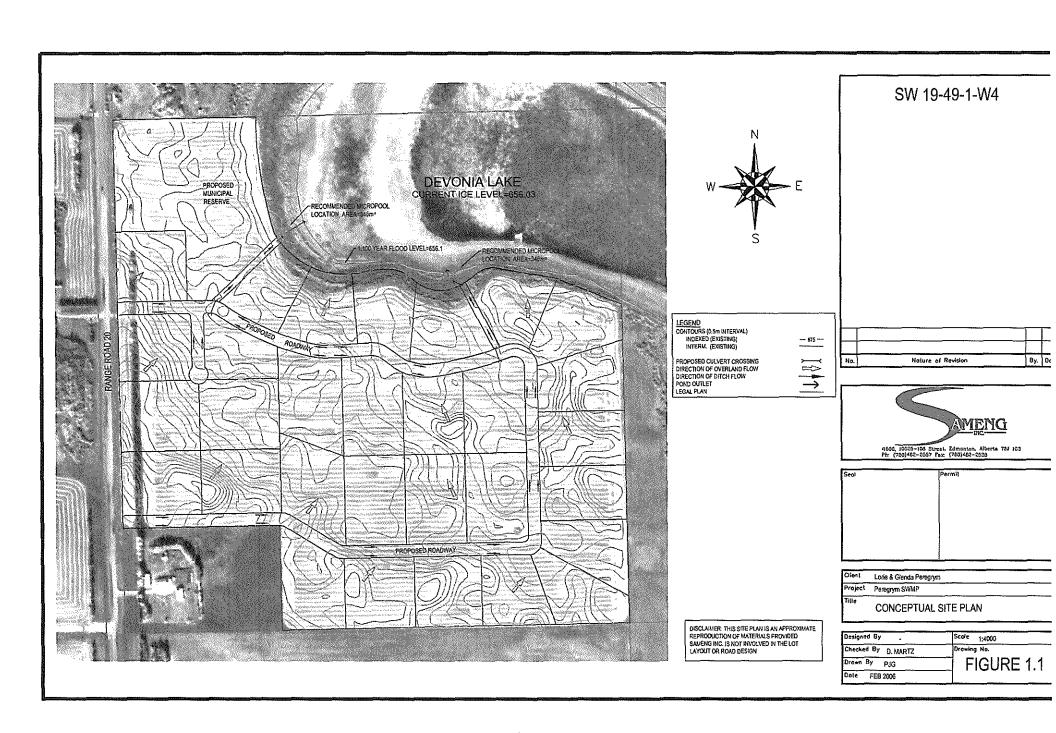
Staging Plan

Lake View Estates will have 30 Country Residential lots that will be developed according to the following Phase Plan.

Service in this order will allow for construction of both entrances off RR20. With the paving of RR20, this will prevent damage to the surfacing project if entrance construction were done a later date.

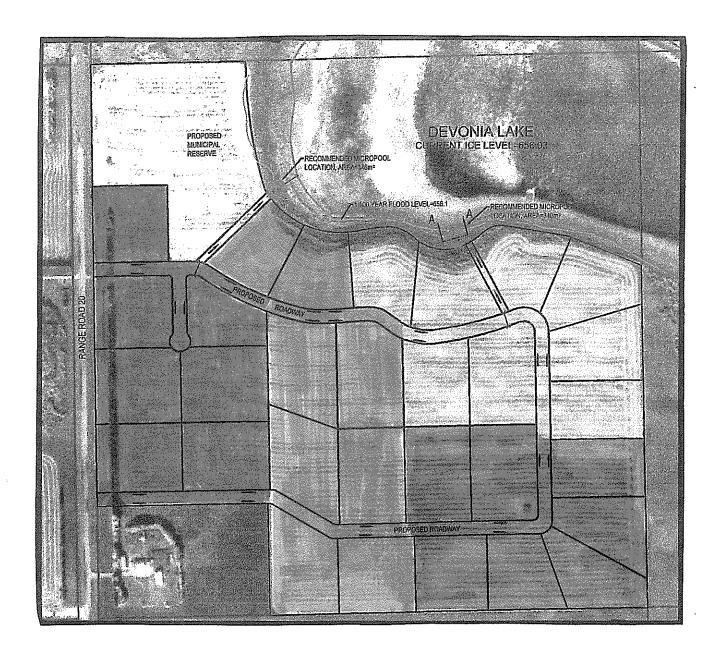
- Phase I
- Phase II
- Phase III

Phase IV
